Phase I Environmental Site Assessment – Portac, Inc. Beaver Mill and Forks Mill, Clallam County, Washington

Phase I Environmental Site Assessment – Portac, Inc.

Beaver Mill and Forks Mill, Clallam County, Washington.

Prepared by Parametrix, Portland, Oregon.

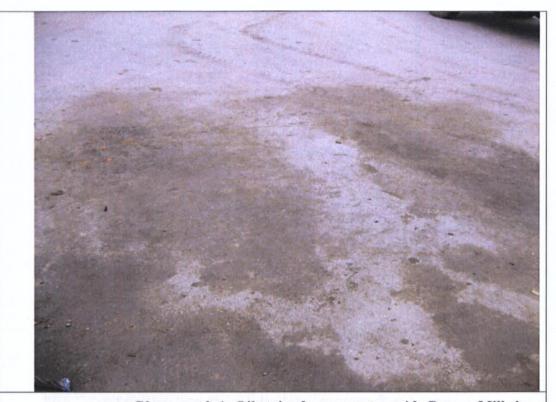
Only the exterior of the maintenance building was examined. During the site walk, several oil stains and spills were observed in the vicinity of the maintenance shop. It appeared that equipment repairs were performed on the asphalt surrounding the shop (Photographs 1 and 2). Near the shop, several empty drums of lubricant were located at the northwest corner of the shop. One drum was not covered and rain water had filled the container (Photographs 3 and 4).

Photograph 1: Oil stained pavement outside Beaver Mill shop

- Areas of identified oil stains and potential environmental impact should be inspected and cleaned up, as appropriate. All stained soil should be excavated and disposed in accordance with local and state regulations.

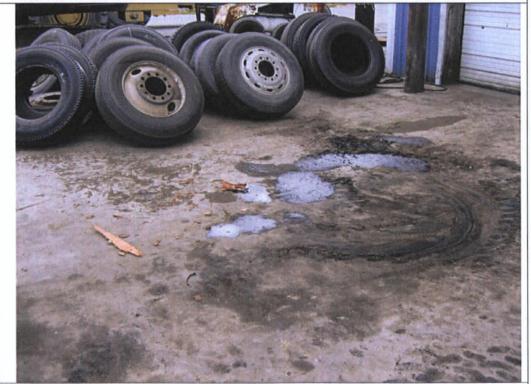
Photograph 2: Oil stained pavement outside Beaver Mill shop

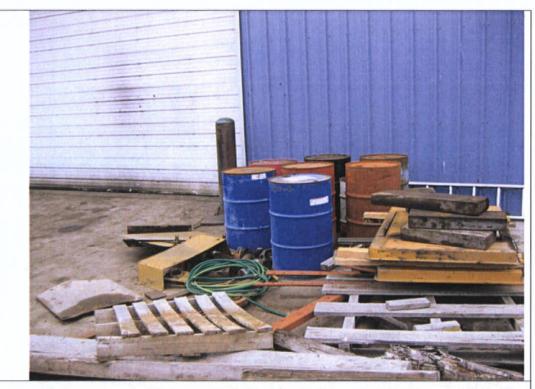
Photograph 3: Empty oil drums outside Beaver Mill shop

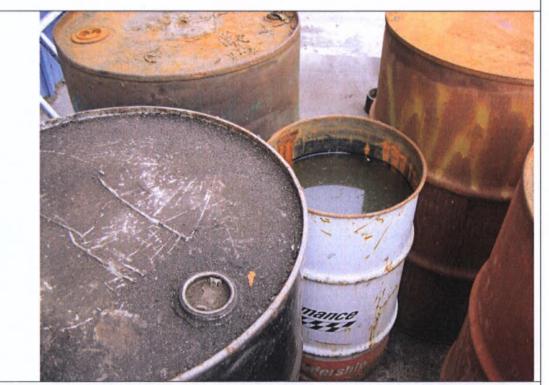
Photograph 4: Empty oil uncovered drum outside Beaver Mill shop

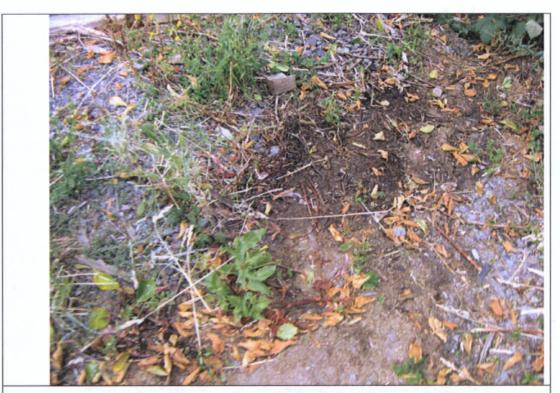
Only the exterior of the mill building was examined. A small oil stain was observed on soil located near the southwest corner of the mill building near the lagoon (Photograph 5). It was stated by Warren Blakeslee that earlier in the year during mill downtime, the mill was washed down with a fire hose and the water washed off of equipment had drained out of the corner of the mill and into the lagoon and slough area located west of the site. A small stormwater infiltration basin was observed north of the mill building where stormwater from the paved area appears to empty into the soil basin. The basin was constructed from concrete blocks and a steel grate over the area where water drains onto the soil (Photograph 6). Oil stains were observed on the paved area prior to entering the basin in trapped sediment. Several absorbent pads and booms containing oil stains were observed in front of the grate apparently in an attempt to collect oil prior to the basin (Photograph 7). However, oil staining was also observed on soil in the basin (Photograph 8). Several pieces of old equipment were observed north of the mill. One of these parts was observed to be leaking hydraulic oil to the ground surface (Photograph 9). An approximately 500-gallon AST was observed along the east side of the mill and appeared to be piped into the mill building (Photograph 10). The tank was not labeled and the contents of the tank were not determined.

Photograph 5: Oil stained soil SW corner of mill

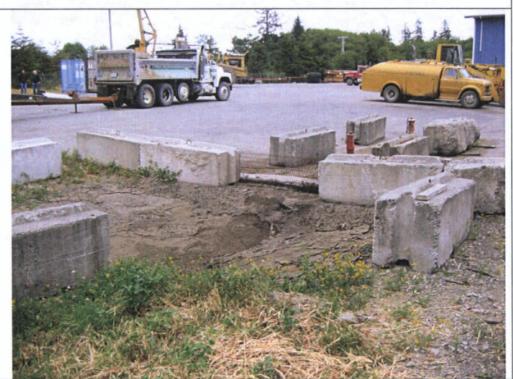
Photograph 6: Stormwater collection basin north of Beaver Mill building

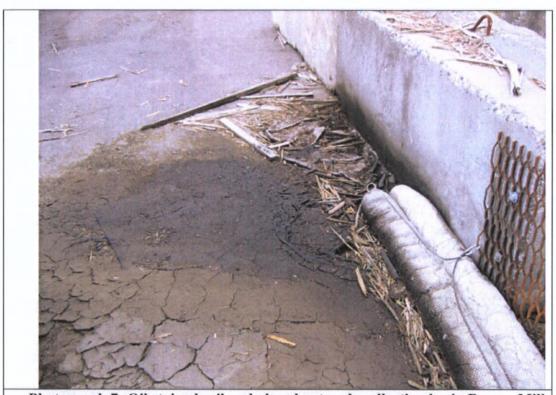
Photograph 7: Oil stained soil and absorbent pads collection basin Beaver Mill

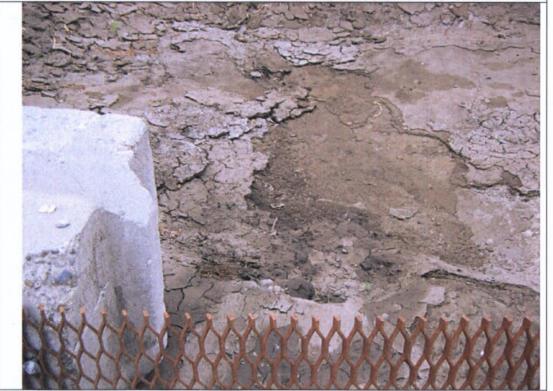
Photograph 8: Oil stained soil at collection basin Beaver Mill

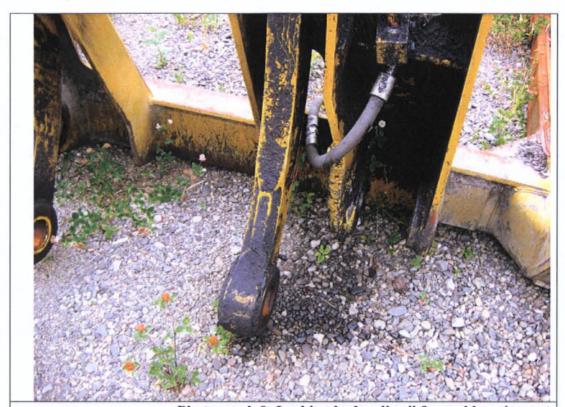
Photograph 9: Leaking hydraulic oil from old equipment

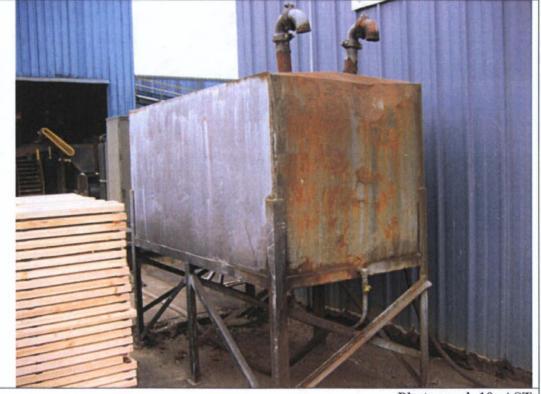
Photograph 10: AST

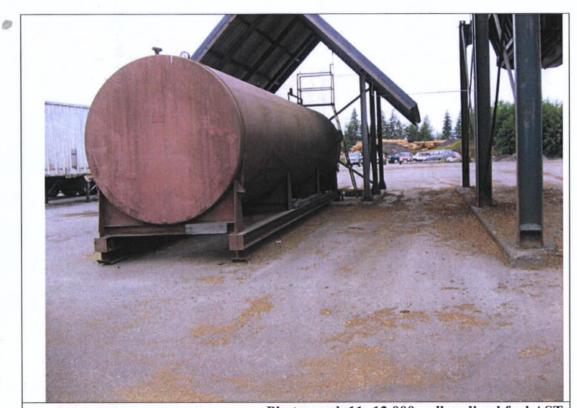
An approximately 12,000-gallon diesel fuel tank is located east of the mill building near the hog fuel bag house hoppers (Photograph 11). The tank appeared to be in good condition and had overhead cover at the dispensing area. A concrete berm and sump was also observed. Several oil stained rags and saw dust was noted near in containment berm (Photograph 12). Major oil staining in the vicinity of the AST was not observed.

Photograph 11: 12,000-gallon diesel fuel AST

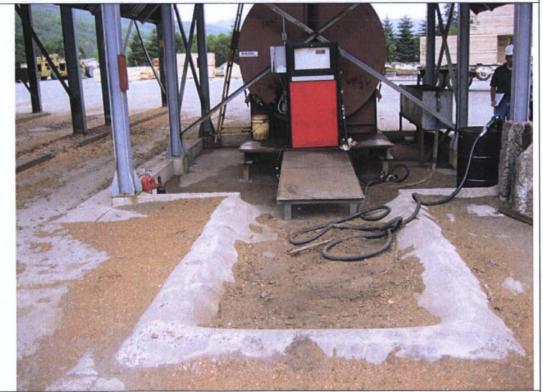
Photograph 12: AST spill containment

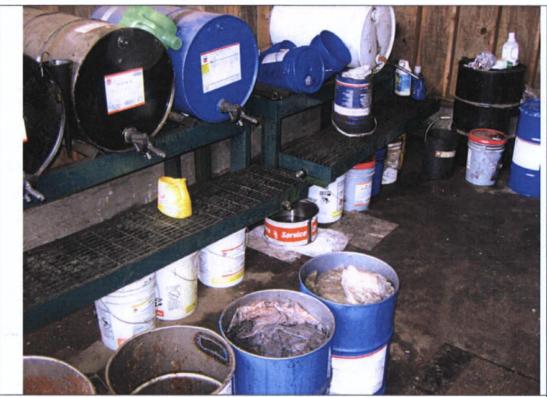
Photograph 13: Lubricant storage shed Beaver Mill

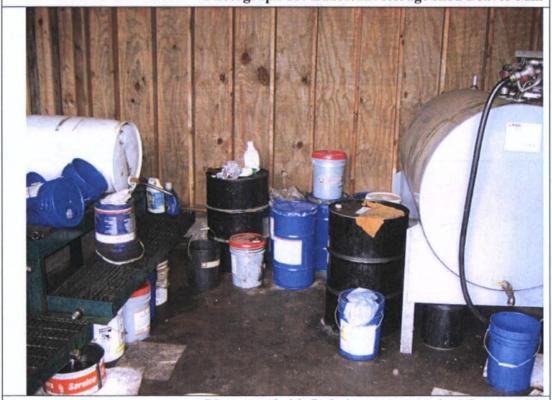
Photograph 14: Lubricant storage shed Beaver Mill

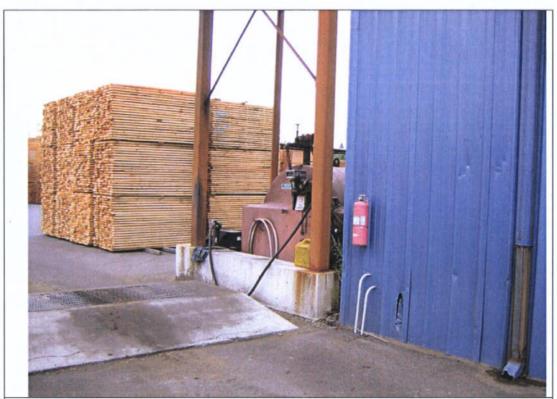
- Oil stained pavement was observed at the 3,000-gallon diesel fuel AST and north of the maintenance shop at the Forks Mill site. Oil stained soil was observed northwest of the maintenance shop and beneath a front loader northeast of the kiln cooling shed.

Photograph 15: 3,000-gallon AST Forks Mill

- All oil storage areas should be reviewed for compliance with Spill Prevention, Control and Countermeasure (SPCC) regulations. Deficiencies with petroleum storage, including overhead cover or secondary containment, should be corrected. An SPCC Plan should be prepared or updated, as needed.

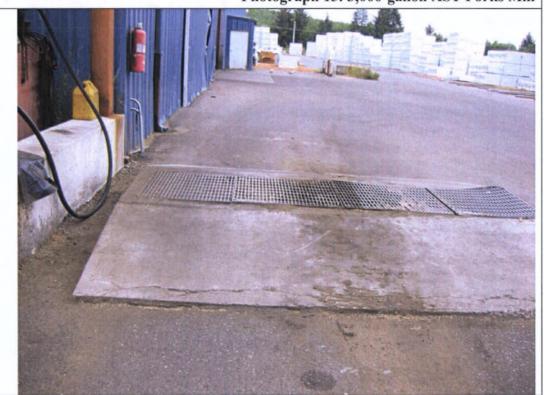
Photograph 16: Spill containment pad Forks Mill

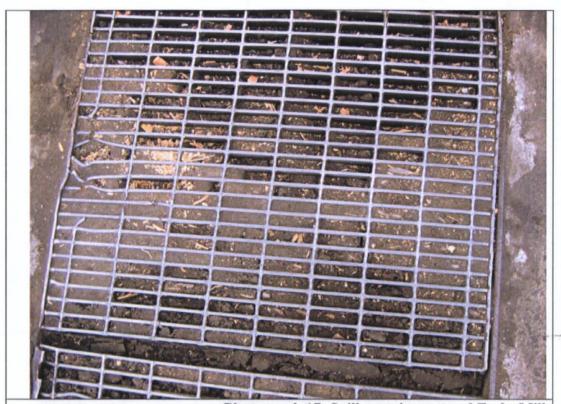
Photograph 17: Spill containment pad Forks Mill

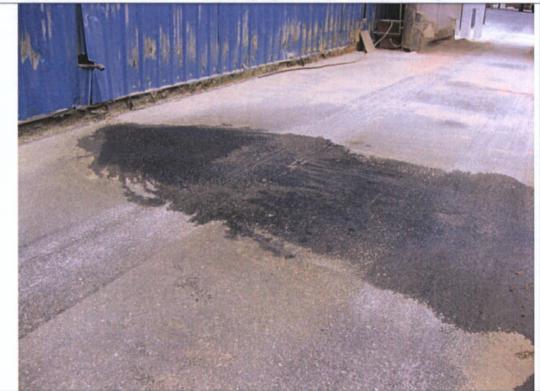
Photograph 18: Discharge water from east side of plan mill building

- 4. Operations at the sites, specifically stormwater runoff and process water discharge, should be reviewed and modified to prevent possible impacts to the subsurface. All areas of oil residue in contact with stormwater discharge (i.e., stormwater infiltration basin at the Beaver Mill site and exterior pipe at the Forks Mill building) should be modified such that oil residue does not enter the stormwater system or subsurface.

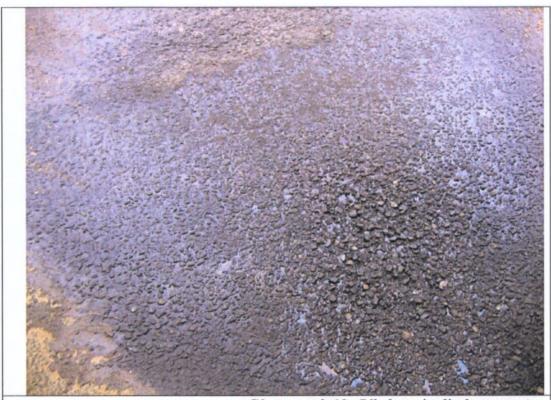
Photograph 19: Oil sheen in discharge water

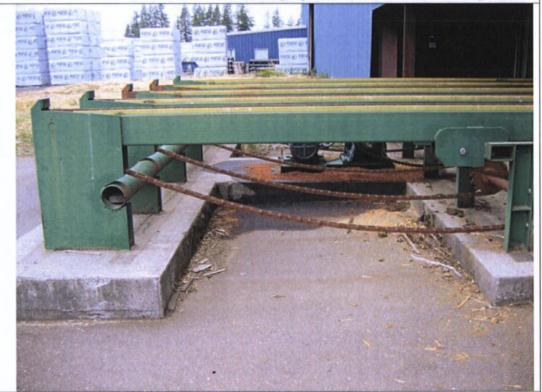
Photograph 20: oil stained concrete south of Forks Mill building

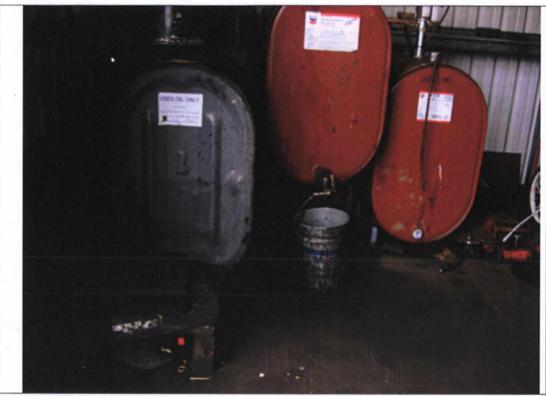
Photograph 21: ASTs in Forks Mill shop

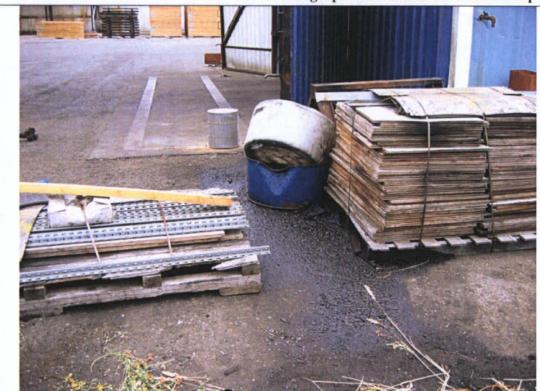
Photograph 22: Oil Stained pavement outside Forks Mill shop

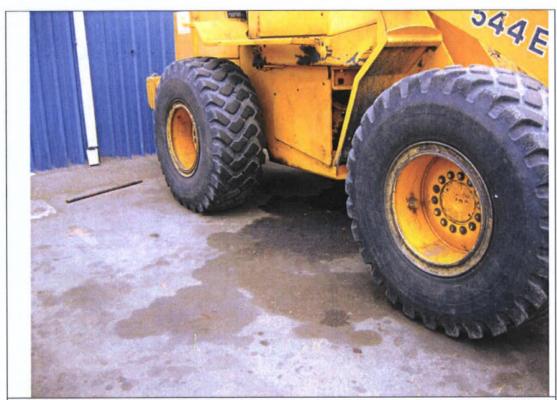
Photograph 23: Oil stained pavement east of Forks Mill shop

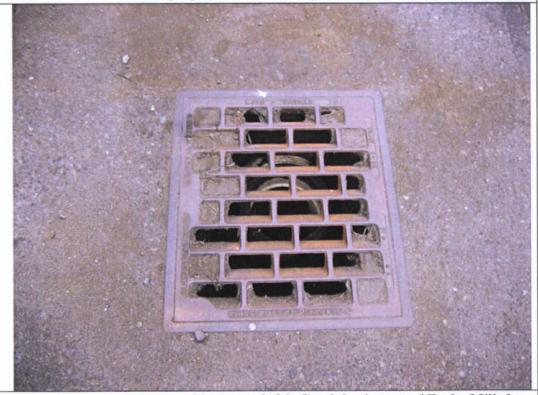
Photograph 24: Catch basin east of Forks Mill shop

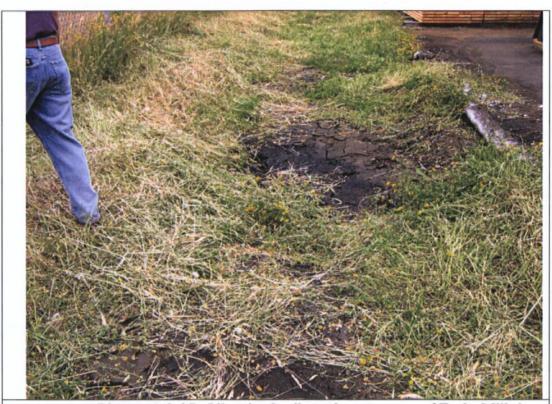
Photograph 25: Oil stained soil northwest corner of Forks Mill shop

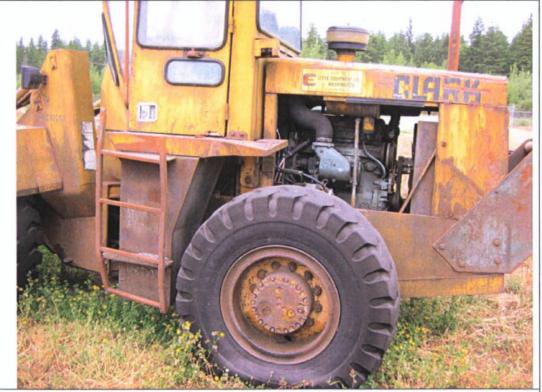
Photograph 26: Front loader dripping oil to soil
